Manhole Inspection Summary

Manhole # S13CC2007MH

Insp Date: **7/26/06 8:20 AM**

Location Address: **2201 CHILHAM RD**

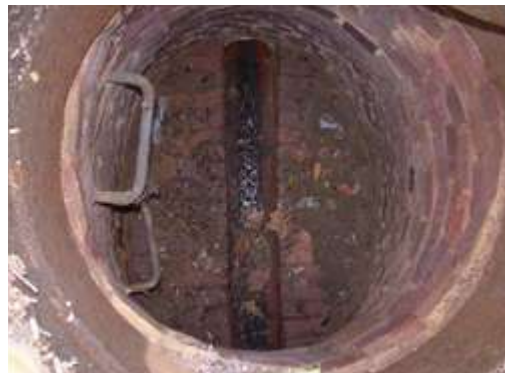
Top View

Surcharge ☒ **Evidence Of Surcharge** Depth: **1** (ft.) ☐ Active Surcharge Present

Evidence of surcharge - Bench debris.
Channel debris.

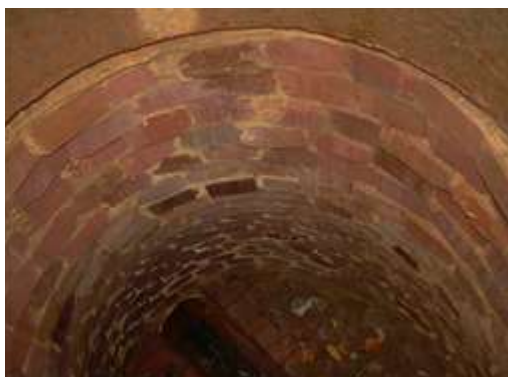
Defect

Frame leaks. Adjustment and Corbel infiltration - other side.

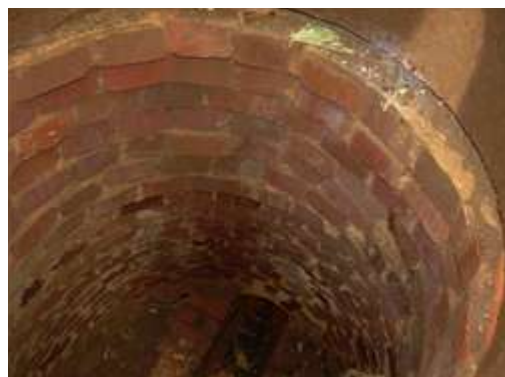
Defect

Frame leaks. Frame offset. Adjustment and Corbel infiltration.

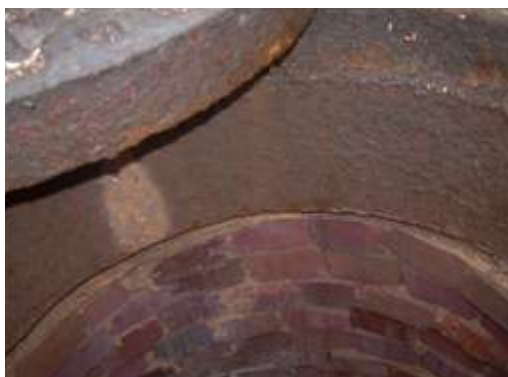
Defect

Frame leaks. Adjustment and Corbel deterioration and infiltration.

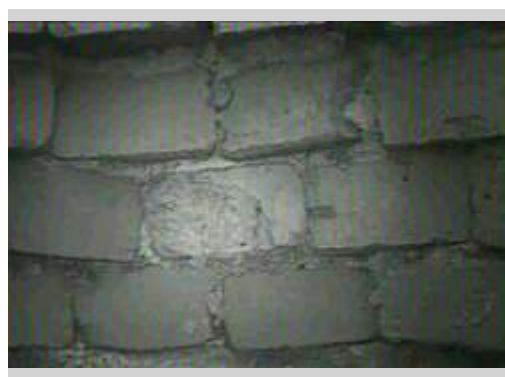
Defect

Corbel deterioration and infiltration.

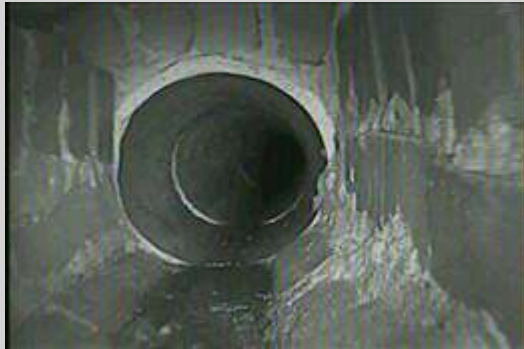
8 in. Circular Gravity Sewer Pipe Out @ 12 O'Clock

Infiltration: **Evidence** Pipe Seal Cond: **Unknown**

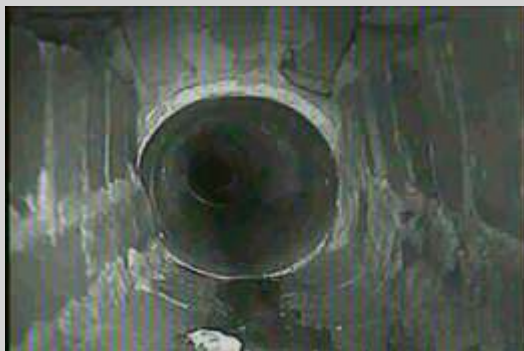
8 in. Circular Gravity Sewer Pipe In @ 6 O'Clock

Infiltration: **Evidence** Pipe Seal Cond: **Unknown**
